Re: Hull WPCF Capacity, Management, Operation and Maintenance ("CMOM") Program
Implementation Annual Report
Town of Hull, MA Administrative Order on Consent, Docket No. CWA-01-AO-16-09

CMOM ANNUAL REPORT

Calendar Year 2016

217319.00
Town of Hull, MA
March 2017

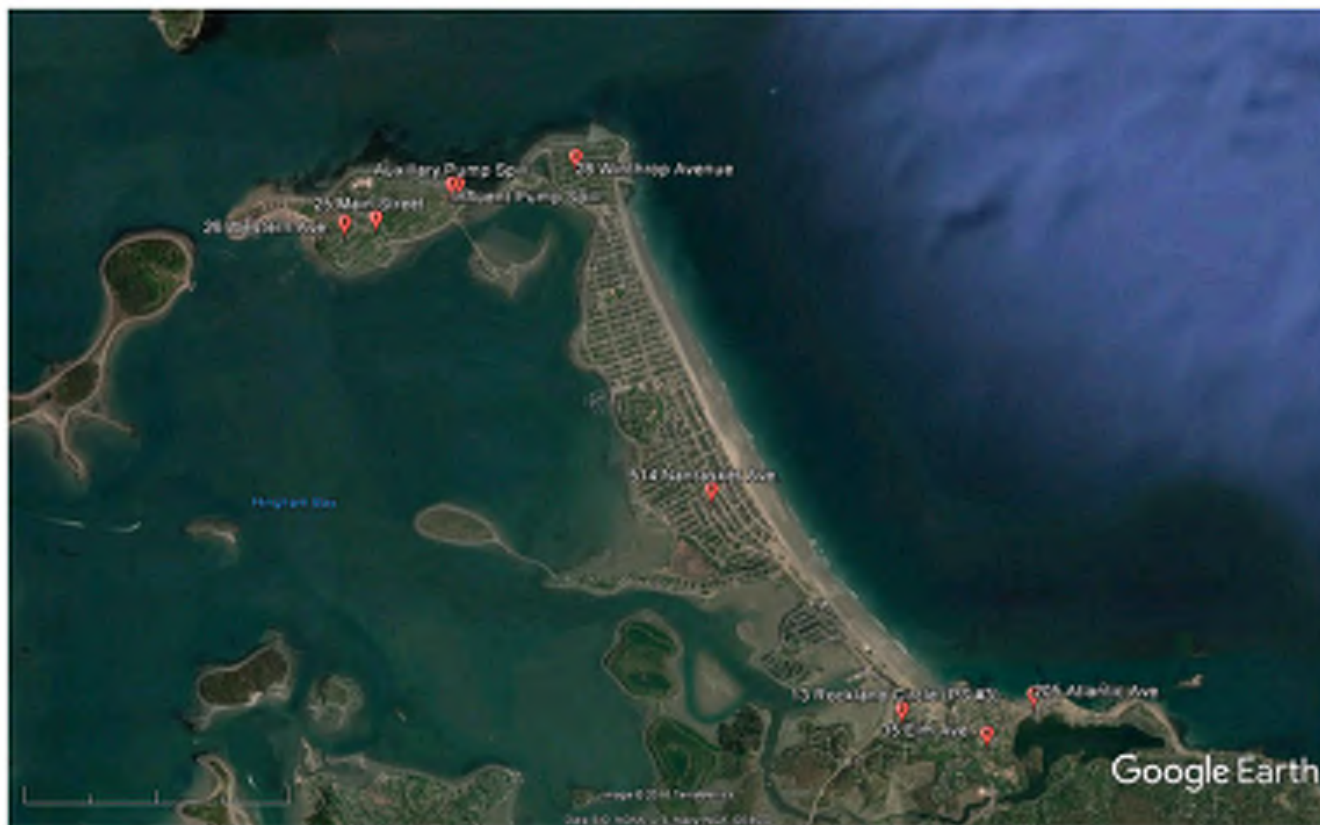
Figure 1: Map of Unauthorized Discharges in 2016

There were nine unauthorized discharge events documented in 2016 (locations shown in Figure 1 below). There were two unauthorized discharges at the WPCF, one unauthorized discharge at Pump Station #3, and three sanitary sewer overflows (SSO's). An additional three SSO's were reported by WPCF staff, but during inspection, found to be privately owned. These SSO's were delegated to the Town of Hull Board of Health to complete follow-up inspections. Brief descriptions as well as current status of each unauthorized discharge are listed in chronological order below, and the full Unauthorized Discharge Summary Table can be found in Appendix D.

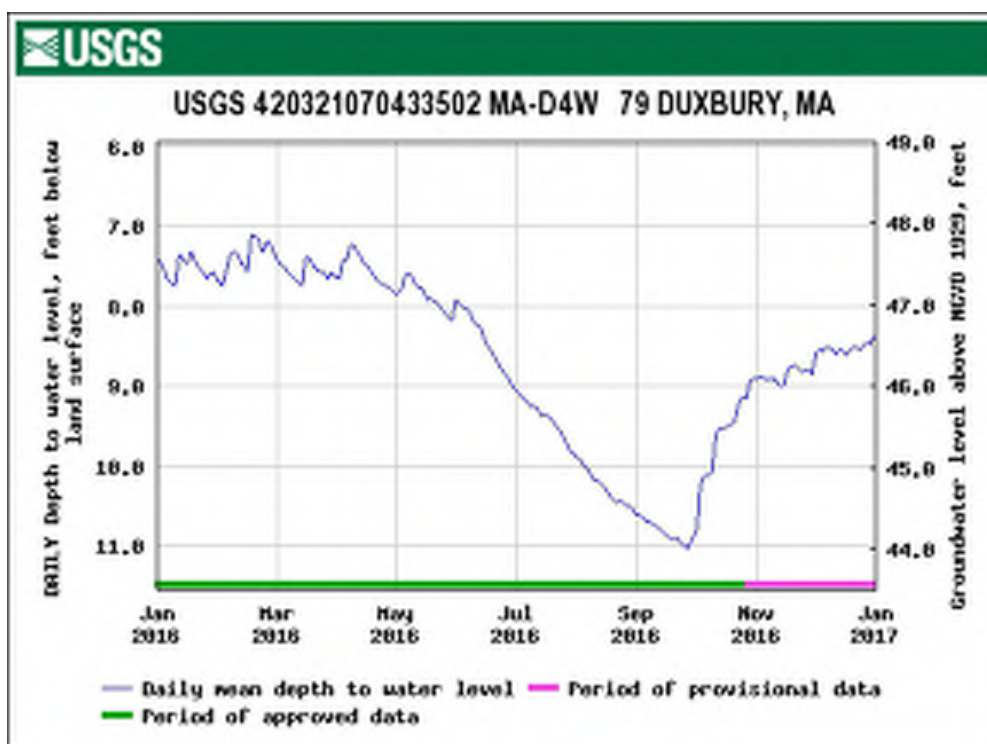
Figure 2: 2016 Groundwater Monitoring Data, USGS

Daily WPCF Effluent Flow and Precipitation data was exported from the WPCF's Hach® WIMS™ data management system. I/I estimates were calculated by reviewing the Highest and lowest 7-day moving averages in comparison to the Base Sanitary Flow (BSF) during the same timeframe. While rainfall increased during this calendar year, the I/I values were expected to be lower due to a decrease in groundwater levels. Massachusetts has been in a sustained drought, and July through December 2016 experienced a State-issued Drought Emergency. Figure 2 below shows the decrease in groundwater level for Southeastern Massachusetts in 2016.

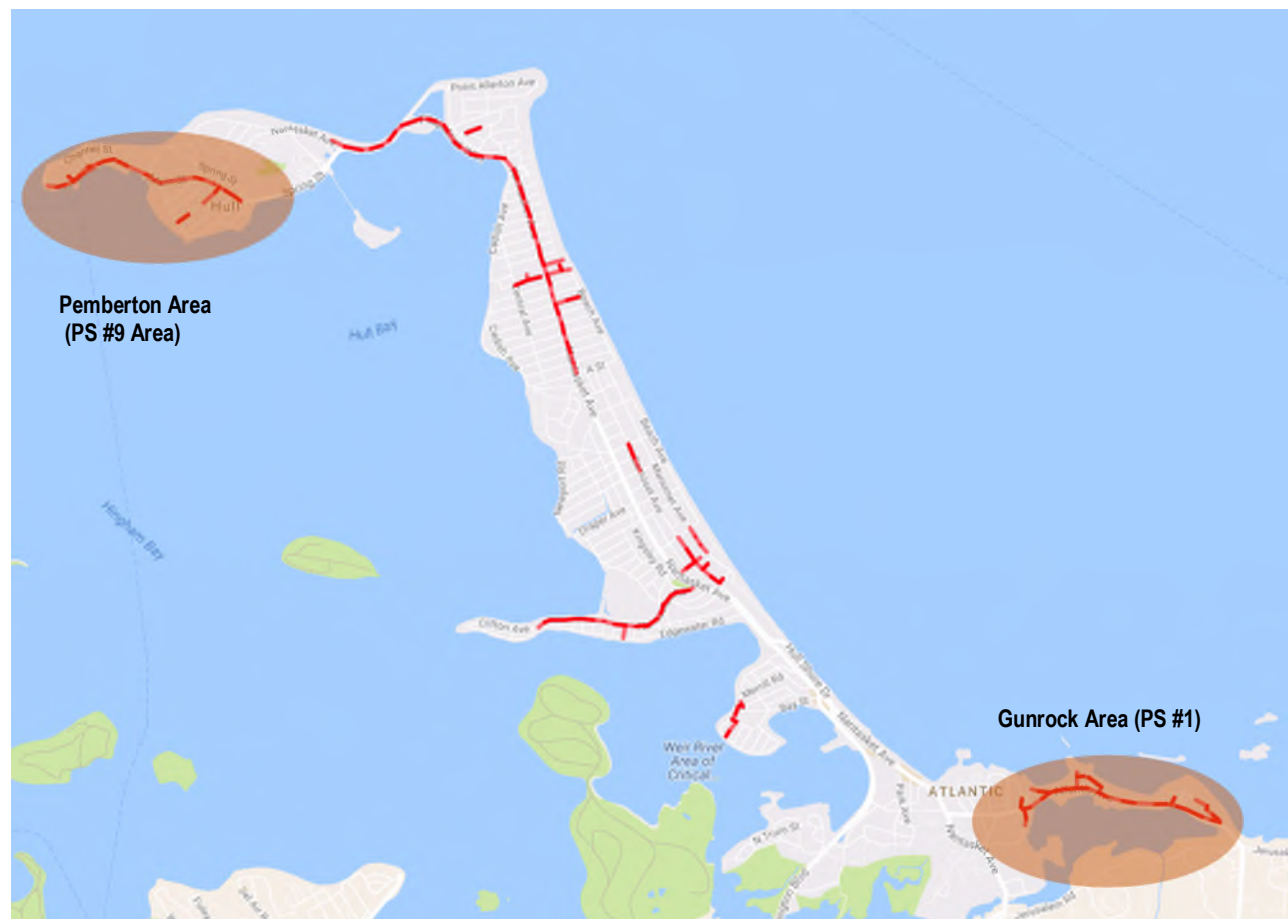
Figure 3: 2017 Planned CCTV and Flow Assessment Scope

After completion of the CCTV inspection, engineering review will provide an updated condition assessment of the Interceptor and prioritize the need for pipeline renewal projects. See Figure 3 for the map of Cleaning and CCTV areas, as well as the targeted flow assessment areas of Pemberton and Atlantic Avenue.

Several insertion flow meters will be utilized to provide subsystem flow data for the Gunrock (Pump Station #1 subsystem) and Pemberton (Pump Station #9 subsystem) areas. Flow assessment data, CCTV, and manhole inspection data will help identify, prioritize, and correct sources of potential I/I to the collection system.

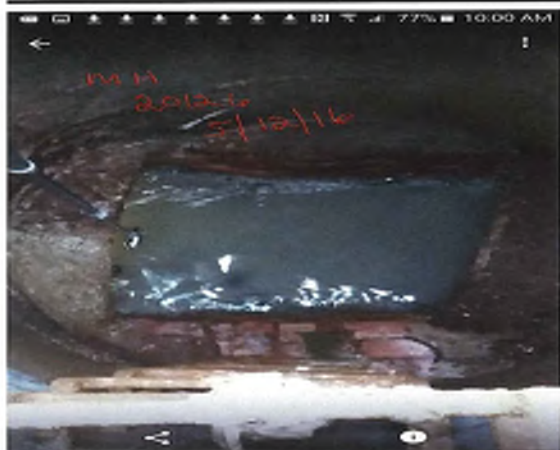
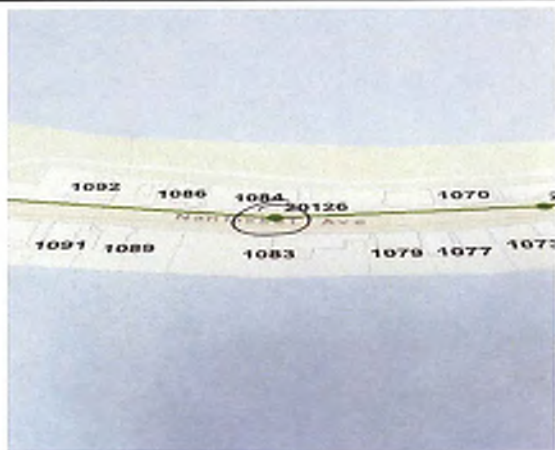
Staff: Eric SuttonService: Opened manhole took pictures with GO PRO downloaded in file

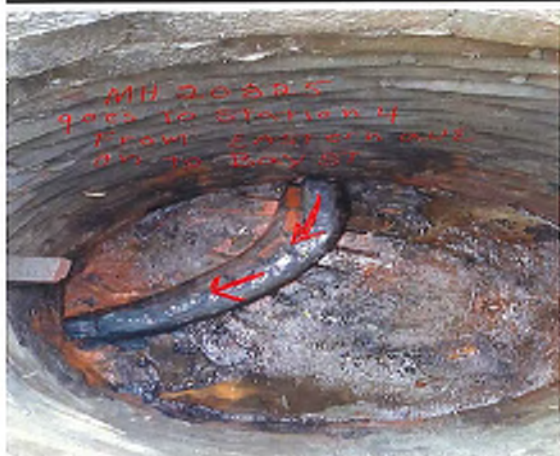
Staff: Eric Sutton**Service:** 230pm ES,RC opened manhole 20825, line flowing freely which ends up at station 4

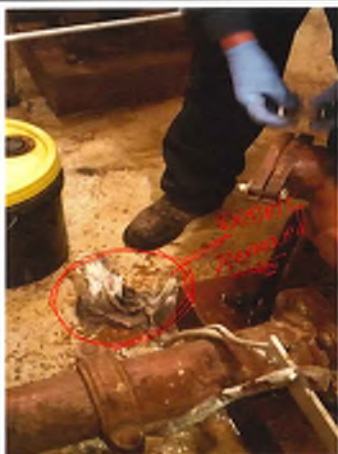
Shows the debris from the impeller removed,

Service: LOTO the pump and remove all the rags and debris from impeller . Flows back to normal now.
Assistance by John Currier, Rick Clark

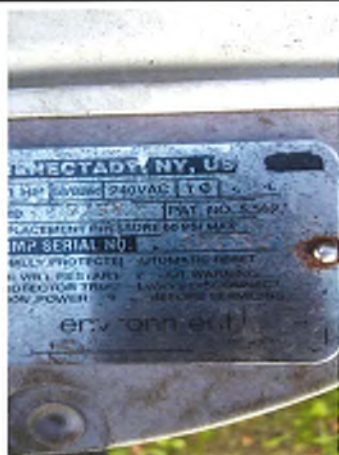
Grinder Pump going in

Service: LOTO Performed. Drained grinder pump pit into tote. Replaced malfunctioning Grinder Pump with Repaired Grinder Pump.

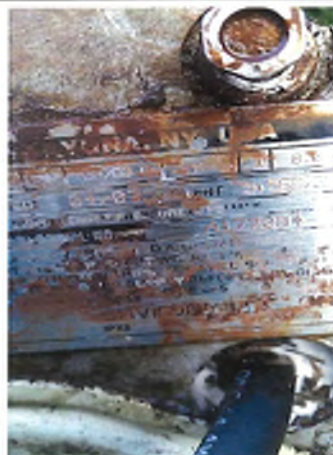
Grinder Pump coming out

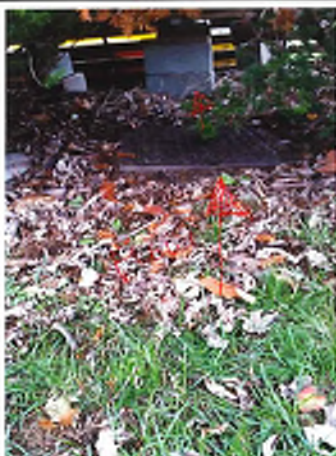
Service: Inspect manholes 20982, 20985 and sure manhole/cleanout in bushes in between #33 and #37. No issues and flowing ok. house no 25, 29,33,37,37A all flow into a lie behind these houses. Clear and flowing. No other cleanout outside. Report back to homeowner.

Cleanout manhole in bushes between #33 and 37

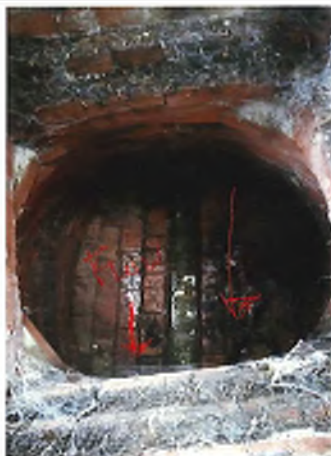
Cleanout manhole in bushes.
